Transition Duct Insulation Casing Replacement

Keeping Rolls Royce Avon and RB211 Gas Turbine Engines Alive

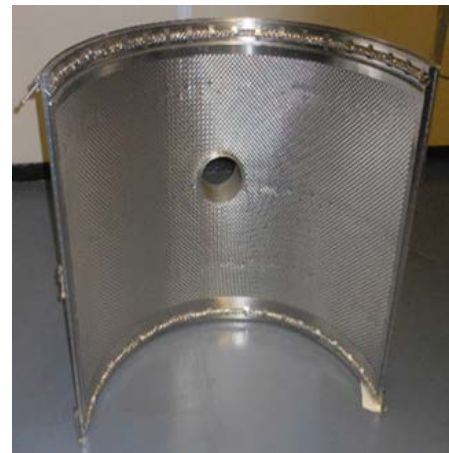
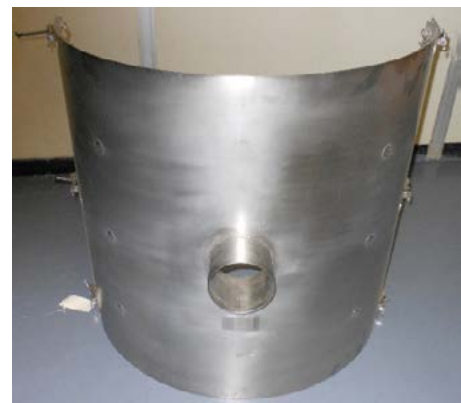
Over the years the inner skin on the Transition Duct Insulation casing has a tendency to wear away and holes begin to appear. When the insulation casing is removed the asbestos can escape into the atmosphere. If the dust is inhaled it can lead to a life threatening condition of the lungs called "Asbestosis".

All new Insulation Casings no longer carry the toxic material asbestos and have been replaced with non-toxic materials that carry out exactly the same task, but to a higher standard.

Prior to undertaking removal of the covers it is beneficial to have a survey carried out to determine whether asbestos and refractory ceramic fibre is present within the existing casings.

Rolaar can assist with the replacement of the 24 Inch Insulation Casings. The 11.2 Inch Insulation Casing is being investigated at this time to see whether it also requires the stripping and replacement of the asbestos lining to a legal condition and status.
